Executive Summary

123 Sample Address, Your City, GA, 12345

Engineer's Foundation Evaluation

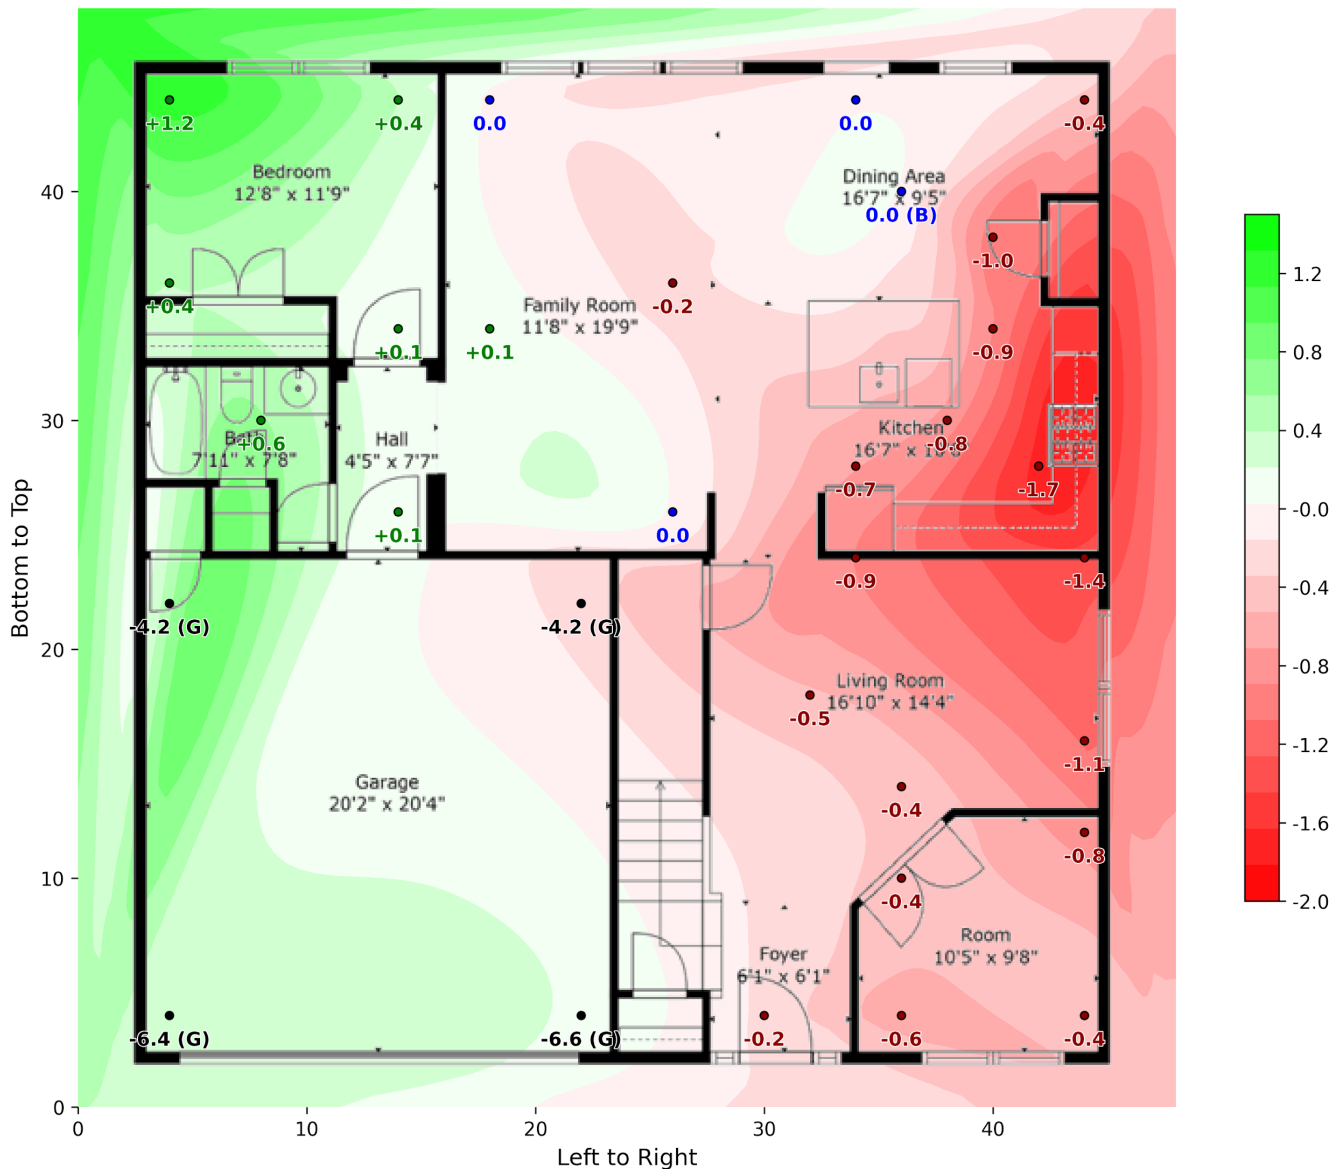
Elevation Plot Graphic (Figure A)

The elevation plot resulted in the graphic as depicted above in Figure A. The red-points and areas are elevation measurements that were lower than the base station elevation (0.0). The green-points and areas are elevation measurements that were higher than the base station elevation (0.0). The blue-points (and white areas) are equal to the base station elevation (0.0). The maximum elevation point was determined to be 1.2 inches and the minimum was -1.7 inches, resulting in an elevation difference of 2.9 inches of difference across the structure.

As documented above, the maximum elevation point of this structure was determined to be 1.2 inches and the minimum was -1.7 inches, resulting in an elevation difference of 2.9 inches of difference across the structure. The elevation deflection across an entire structure should remain within 0.5 to 1-inch depending on the age of the structure. Measured differences approaching 2-inches are a sign of foundation fatigue. The maximum allowable elevation difference is subjective, depending on other factors such as the visual condition and age of the structure (19 year(s) old).

Based on observed elevations of the foundation from the elevation plot, the structure cannot be considered fully stable. Elevation differences do not fall within industry standards or tolerable limits. These findings indicate that the foundation does not have consistent and uniform elevation demonstrating continued movement of the foundation.

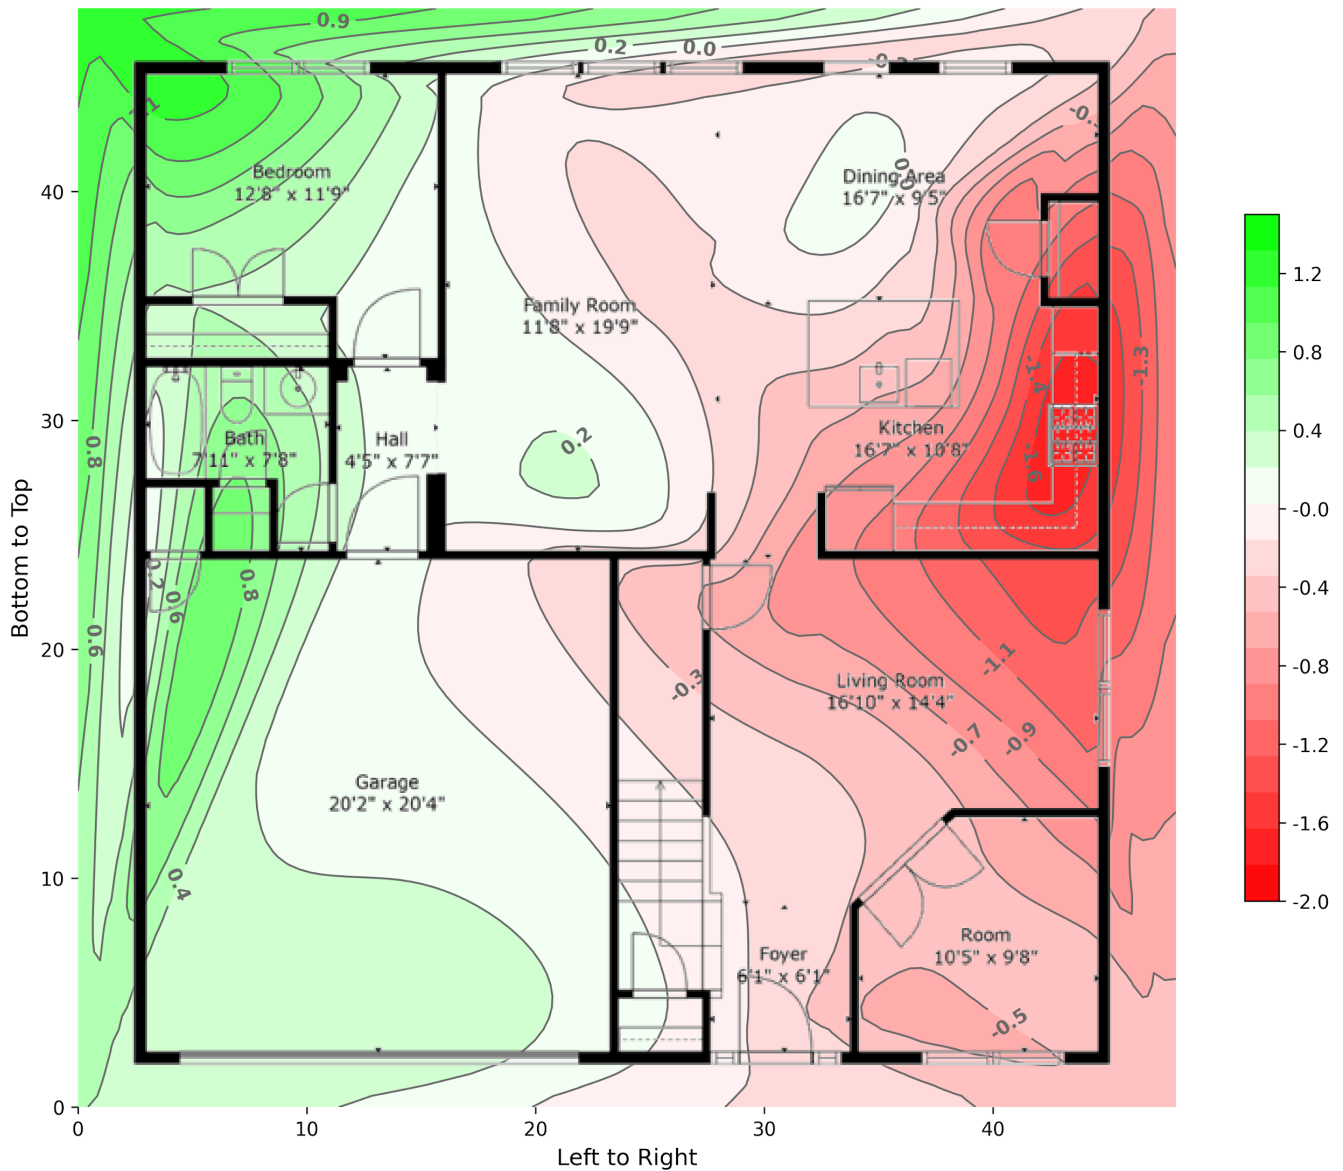
Mesh Contour Graphic (Figure B)

The mesh contours graphic depicted above in Figure B is similar to the elevation plot. The red, green, and white areas depict areas that are lower, higher, and equal to the base station elevation (0.0). The contour intervals are labeled.

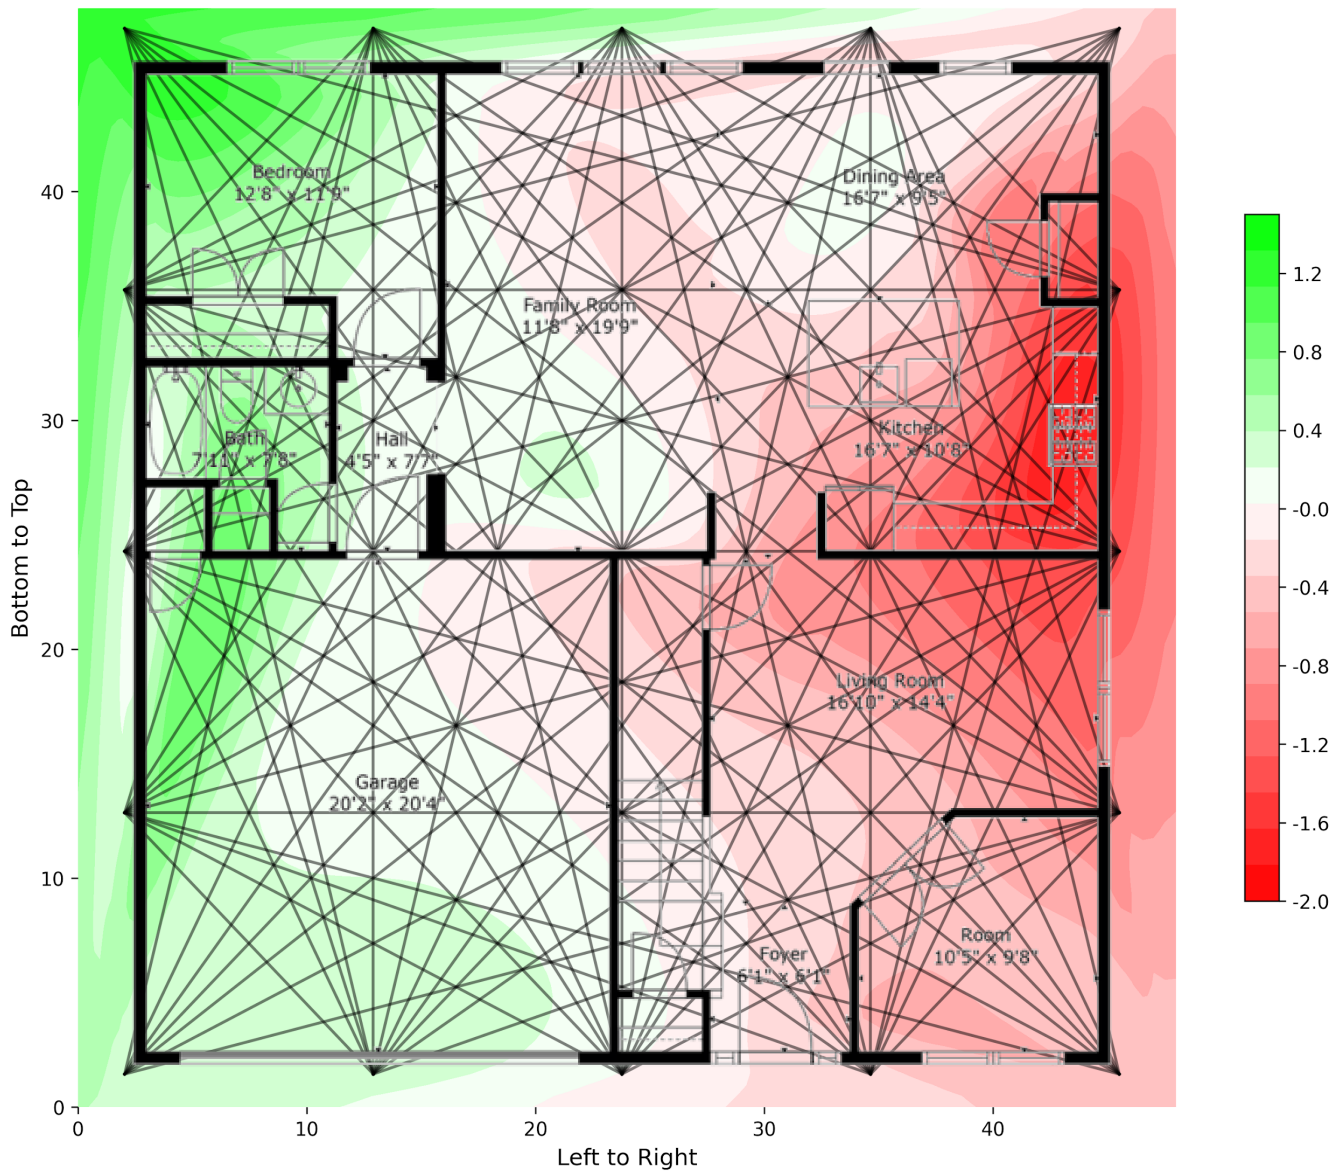
All Profiles Graphic (Figure C)

Below is a graphic that shows the locations of deflection and tilt profiles that were calculated. The total profiles calculated was 79 with a total usable profiles (above the effective length threshold) of 76.

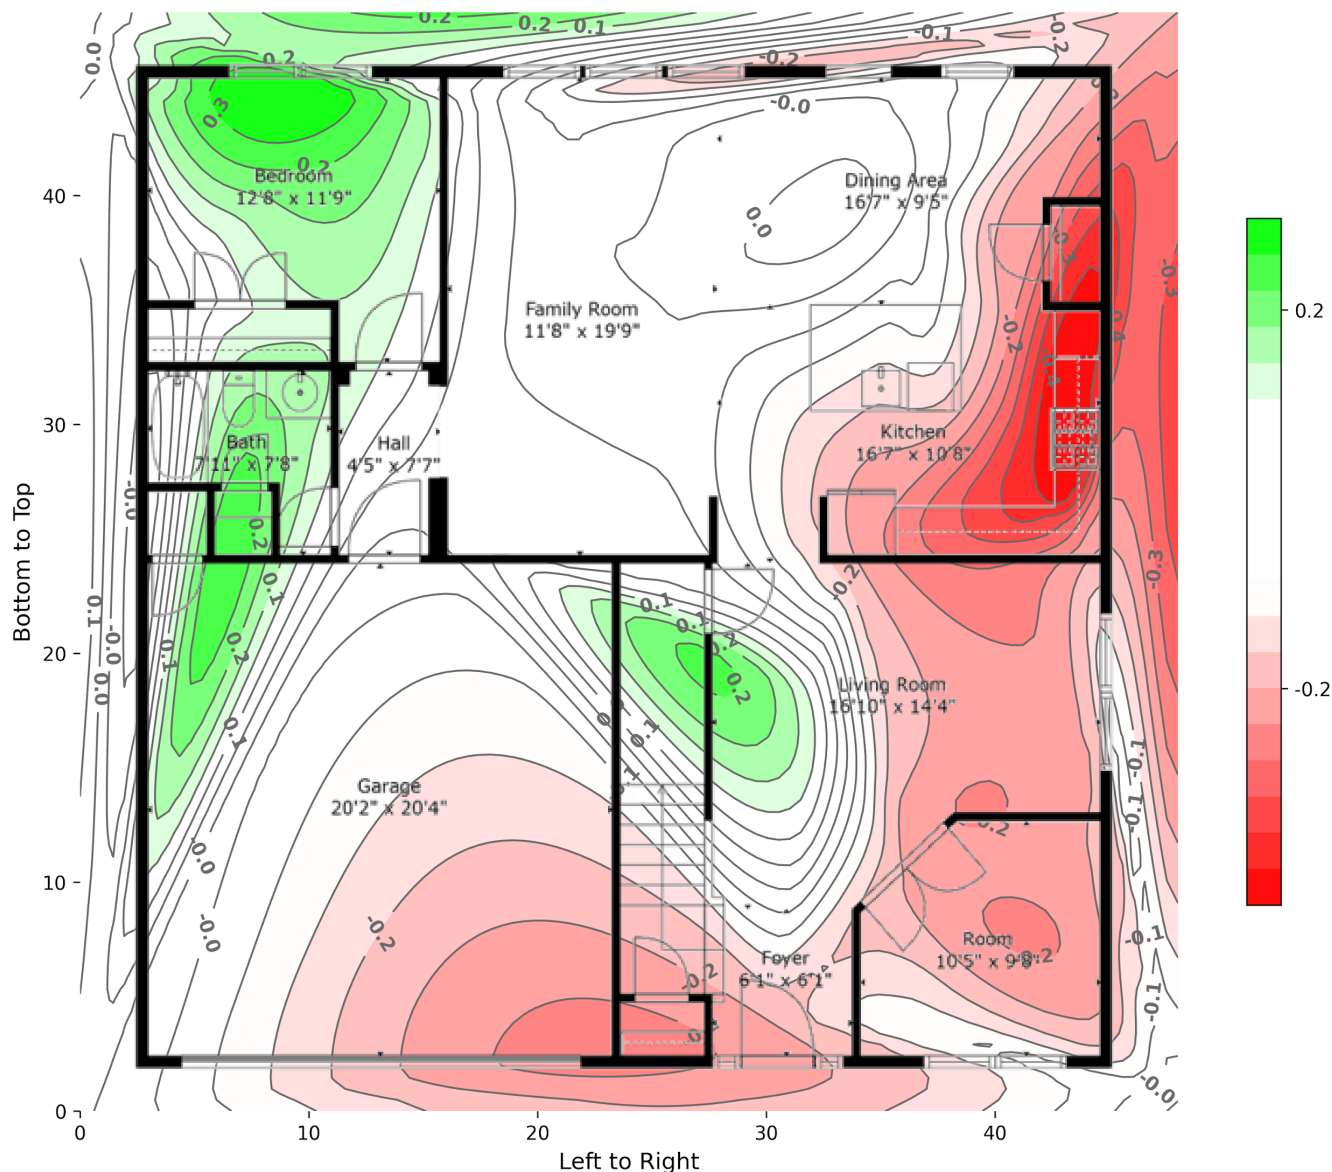
Elevation Plot Difference Graphic (Figure F)

The mesh contour graphic above in Figure F shows areas in red that are lower than the baseline elevation plot and areas of green that are higher than the baseline elevation plot (from the provided drawing completed in 1998). The darker the color (both red and green) the larger/smaller the elevation differences.

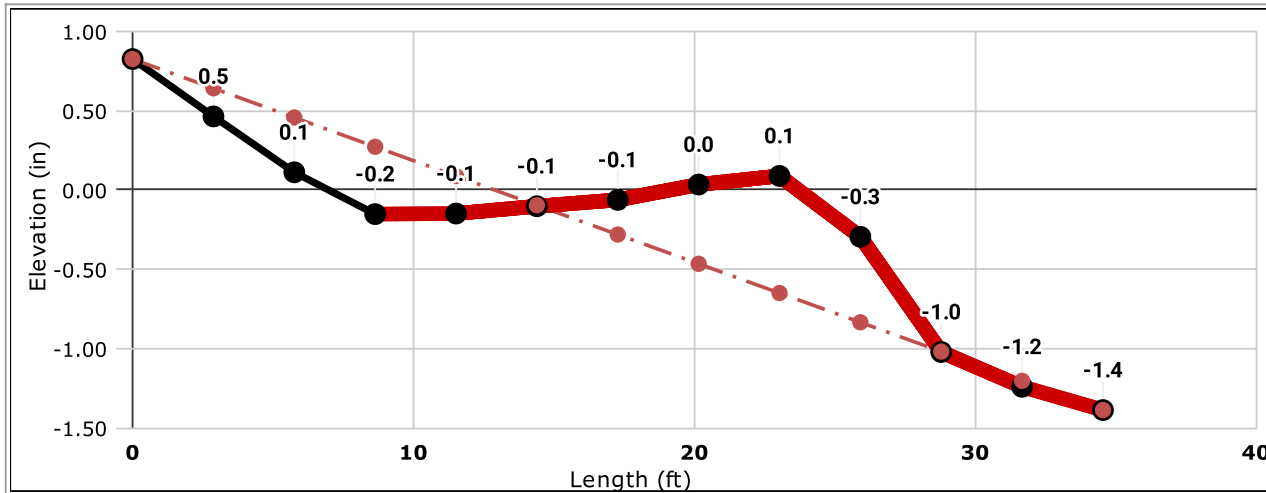
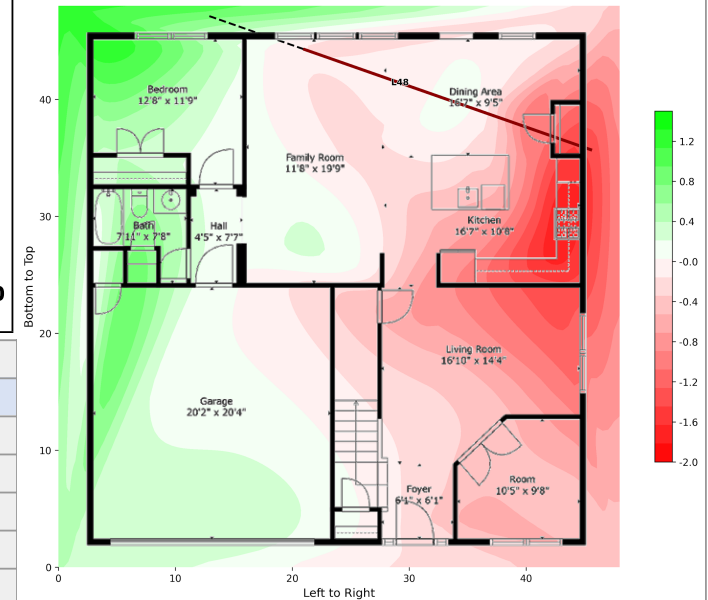
Exhibit A: Identified Deflection/Tilt Failure (L48)

Performance Output							Point 1	Point 2	Point 3
Deflection & Tilt	Pass/Fail	Actual		Result Description					
Deflection 1 (using k)	FAIL	L /	281	EXCEEDS THE kL/360 (L/340) LIMIT BY 21%			4	9	11
Deflection 2 (using k)	FAIL	L /	281	EXCEEDS THE kL/360 (L/340) LIMIT BY 21%			5	9	12
Deflection 3 (using k)	FAIL	L /	300	EXCEEDS THE kL/360 (L/340) LIMIT BY 13%			4	9	12
Deflection 4 (using k)	FAIL	L /	323	EXCEEDS THE kL/360 (L/340) LIMIT BY 5%			5	9	13
Deflection 5 (using k)	FAIL	L /	326	EXCEEDS THE kL/360 (L/340) LIMIT BY 4%			6	9	13
Tilt	PASS	0.53	%	USING 53% OF THE ALLOWABLE 1% LIMIT
