Executive Summary

123 Sample Address, Your City, GA, 12345

Engineer's Foundation Evaluation

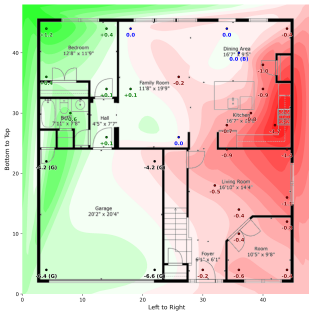
Figure A

This evaluation indicates clear signs of foundation issues. Calculations were not found to be within industry standard limits. Remedial measures are required to bring the foundation to a more level condition. It is recommended that foundation stabilization be completed as soon as possible, if possible within the next year. In addition, visual deficiencies noted should be resolved after foundation improvements have been completed. We also recommend you perform another house elevation plot after repairs have been completed to memorialize the elevation changes. Due to the nature that foundation work is recommended, it is imperative that you read the entire report in detail for a comprehensive explanation of this conclusion.
